## TECHNICAL SERVICE BULLETIN

TSB 2016-1002 Level: 2

Topic	Overtightening of 4-in-1 Ball Valve Tool (Core Removal Tool) can lead to failure and potential venting of the system under service.
Affected Units	4-in-1 Ball Valve Tool, All Models
Resolution	This tool should be tightened by hand only as shown in procedure below.

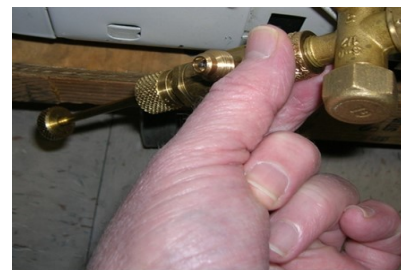
Figure 2

In testing, it was determined that over-tightening this tool during installation can cause failure resulting in the potential venting of the system under service.

1. ASSURE PROPER ALIGNMENT AND ACCESS TO THE SIDE PORT AND VALVE HANDLE BEFORE TIGHTENING THE TOOL (Figure 1)
2. TIGHTEN BY HAND ONLY (Figure 2)
3. IF ANY LEAKAGE OCCURS, REPLACE THE GASKET WITH P/N 18973 (5 PACK) (Figure 3)

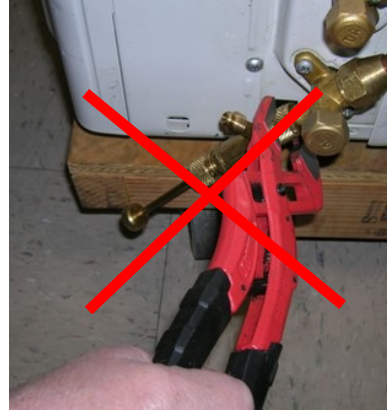
**Figure 4**

1. TIGHTEN WITH ANY TOOL  
(Figure 4)

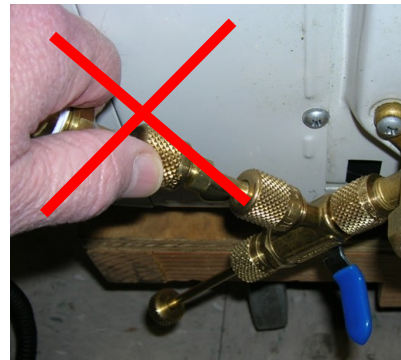
**Figure 5**

2. USE ANY ATTACHMENT TO THE  
SIDE PORT FOR ADDITIONAL  
LEVERAGE TO TIGHTEN THE  
TOOL  
(Figure 5)
