## DC ground fault locating under difficult conditions An AC coupling tale...

### **CASE STUDY**

## DC ground fault locating in the presence of unwanted AC coupling

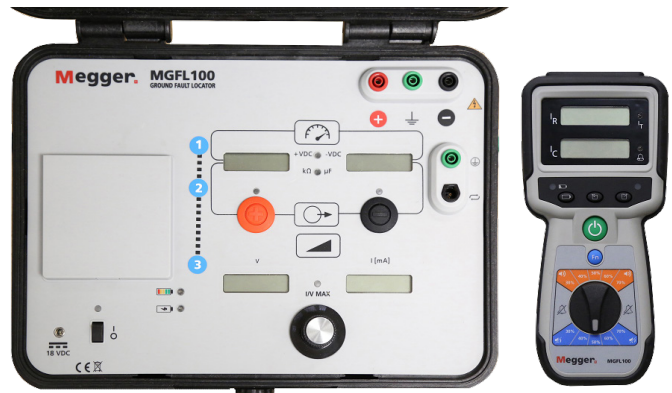
The MGFL100 is a battery ground fault locator. It can locate faults up to 400 k $\Omega$ . It can automatically identify real faults as well as leakage current. The unit will alarm when it locates the real fault.

The MGFL100 also can trace faults on IT grounded AC systems. In addition, the MGFL100 receiver can be placed in a 50/60 Hz mode to trace any AC current.
