## Ground fault tracing: CT magnetization

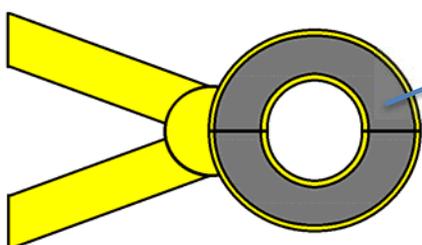
The iron core will have wire wrapped around it in order to transfer an AC signal. However, a DC signal will magnetize the iron core.

When tracing ground faults on ungrounded DC systems, one should not assume that there will be no DC current flowing through the circuit. If a current clamp (CT) is placed on a line with DC current, the DC current will cause the CT, namely its iron core, to magnetize. The higher the DC current, the stronger the magnetization will be.

This can make removing the CT quite difficult. The CT can be damaged in the process of removal. In some cases, the CT cannot be removed from the line.

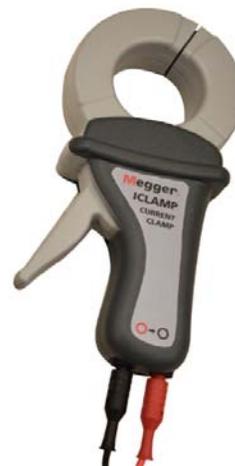
The mini active CT for the MGFL100 uses a flux gate technology, allowing a gap in the core. This also greatly reduces magnetization effects.

When tracing low level AC signals or pulses, the larger and purer the CT core, the higher its permeability and the more sensitive the CT will be. This makes the CT better at measuring these low currents used to trace faults. However, this also makes such a core more susceptible to magnetization. The MGFL100 CT is very sensitive but will not have any significant magnetization. This is because the core is made of a mu-metal compound. This core maintains high permeability but is far less prone to magnetization. If it is placed on an energised DC line, it can still easily be removed without any damage.
