## APPLICATION NOTE – Manufacturing

# BOTTLED WATER COMPANY IMPLEMENTS LARGE- FORMAT IR WINDOWS

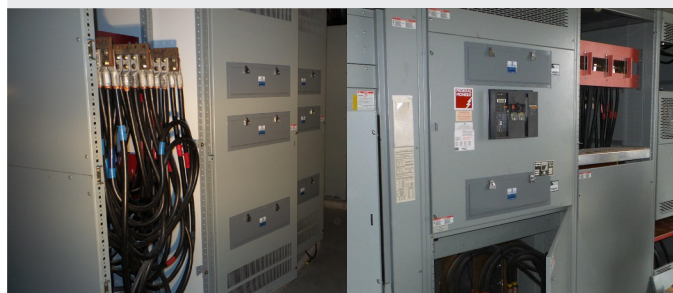
Installation Requirements:  
Incoming line connections  
Main Breaker

Incoming line connection and main breaker cabinets were also fitted with 24-inch windows
