# FLIR Si124™

## Industrial Acoustic Imaging Camera

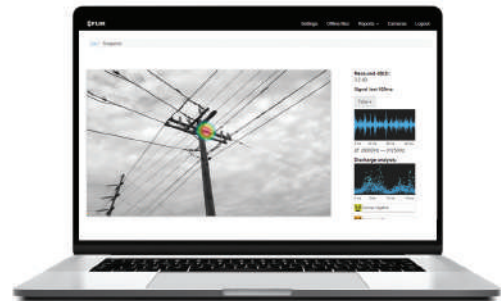
Example of Si124 PD severity assessment

**Analysis parameters**

Distance: 25 m

Voltage: 69 kV

Location: ~ cable joint

This is likely to be a very strong surface or internal discharge. Surface or internal discharges on cables, terminations, and joints will progress over time and might rapidly escalate to insulation breakdown.

Immediate action. Visual inspection. Cleaning of polluted surfaces. Repair or replacement of the components.
