## The revolution and evolution of industrial acoustic imaging

Revealing unseen and unheard air and gas leaks is becoming faster and easier

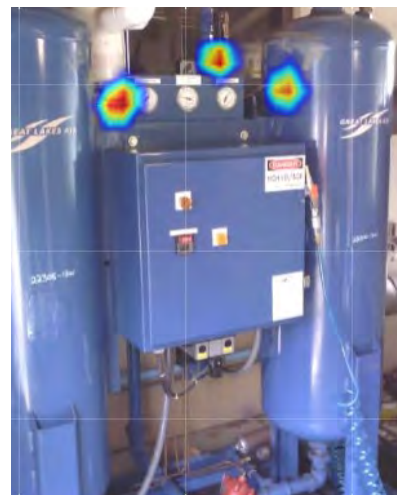
Figure 1. With portable acoustic imagers, technicians can quickly locate compressed air leaks simply by pointing the device at an asset or system or scanning a large area – from a safe distance, with the line still running, and no matter how noisy the plant.

The introduction of portable acoustic imaging for air-system condition monitoring was revolutionary and the solutions proved hugely successful. Suddenly, technicians could quickly locate leaks simply by pointing the device at an asset or system or scanning a large area – from a safe distance, with the line still running, and no matter how noisy the plant. Seeing the sound in context coming from hoses, fittings, or connections allowed them to quickly make corrections and considerably reduce costs (see Figure 1).

For instance, leaks can be detected in minutes and entire plants can be inspected in hours, during peak operations, with the Fluke ii900 Industrial Acoustic Imager. Launched in 2019, the imager uses SoundSight™ technology to show leaks by visualizing them as a steady red spot. It isolates the sound frequency by filtering out background noise and presents a combined SoundMap and visual image that identifies the source of the leak. Saved images can be exported for reporting.

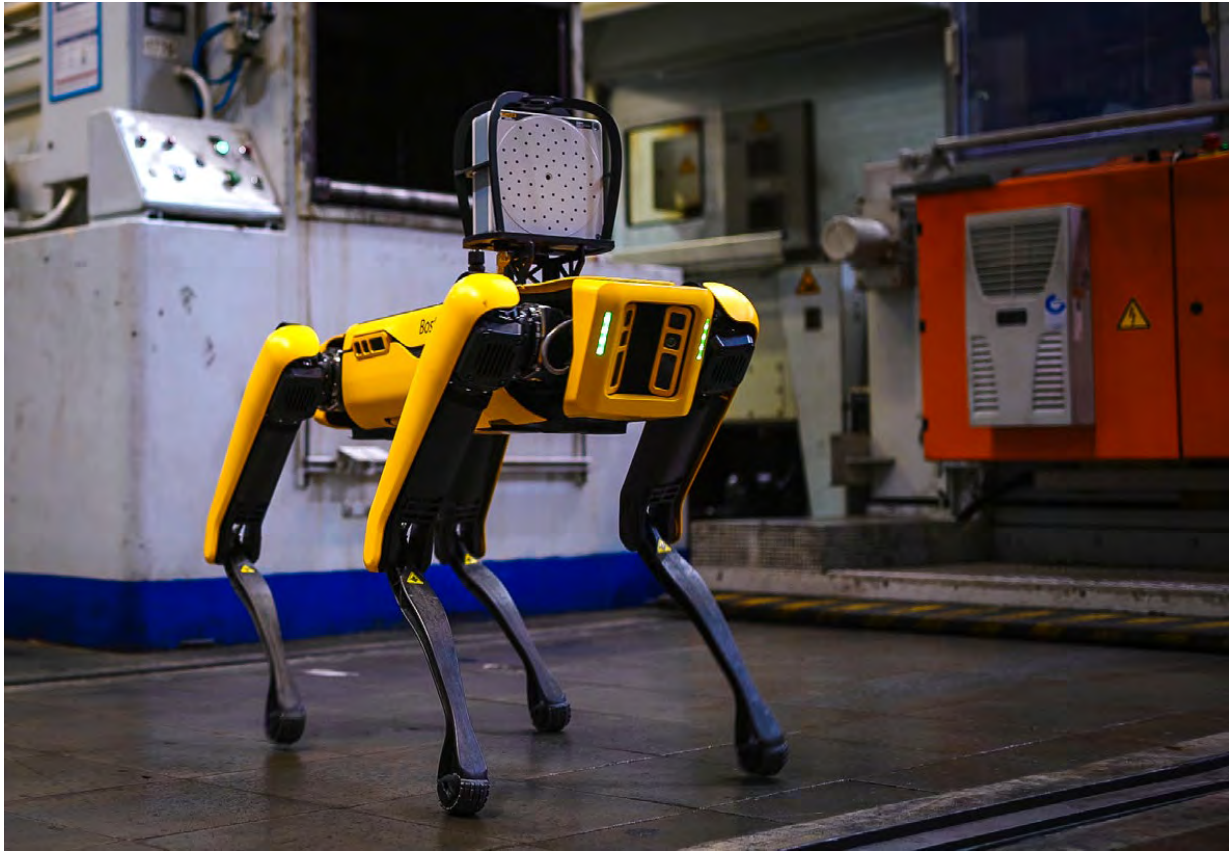
Figure 3. A new partnership with Boston Dynamics, announced in July 2021, couples its dog-like agile mobile robot Spot with the SV600 payload.

A new partnership with Boston Dynamics, announced in July 2021, couples its dog-like

agile mobile robot Spot with the SV600 payload (see Figure 3).
